Per the Illinois Compiled Statutes, 625 ILCS 5/11-208.6 Automated Traffic Law Enforcement System:

A Red Light Running (RLR) Photo Enforcement System was installed at the intersection of IL Rte. 7 (Larkin) at Moen Avenue on April 22, 2012, after finding limited success with other attempted measures to promote safer driving and improve compliance with traffic laws. The following statistical analysis was performed through 2015. Calendar year 2016 was not included as the Illinois Department of Transportation (IDOT) has not yet completed collecting all data. The statistical analysis will be updated annually, as collected data becomes available from IDOT.

**IL Rte. 7 (Larkin) at Moen Avenue**  
**Rockdale, IL**

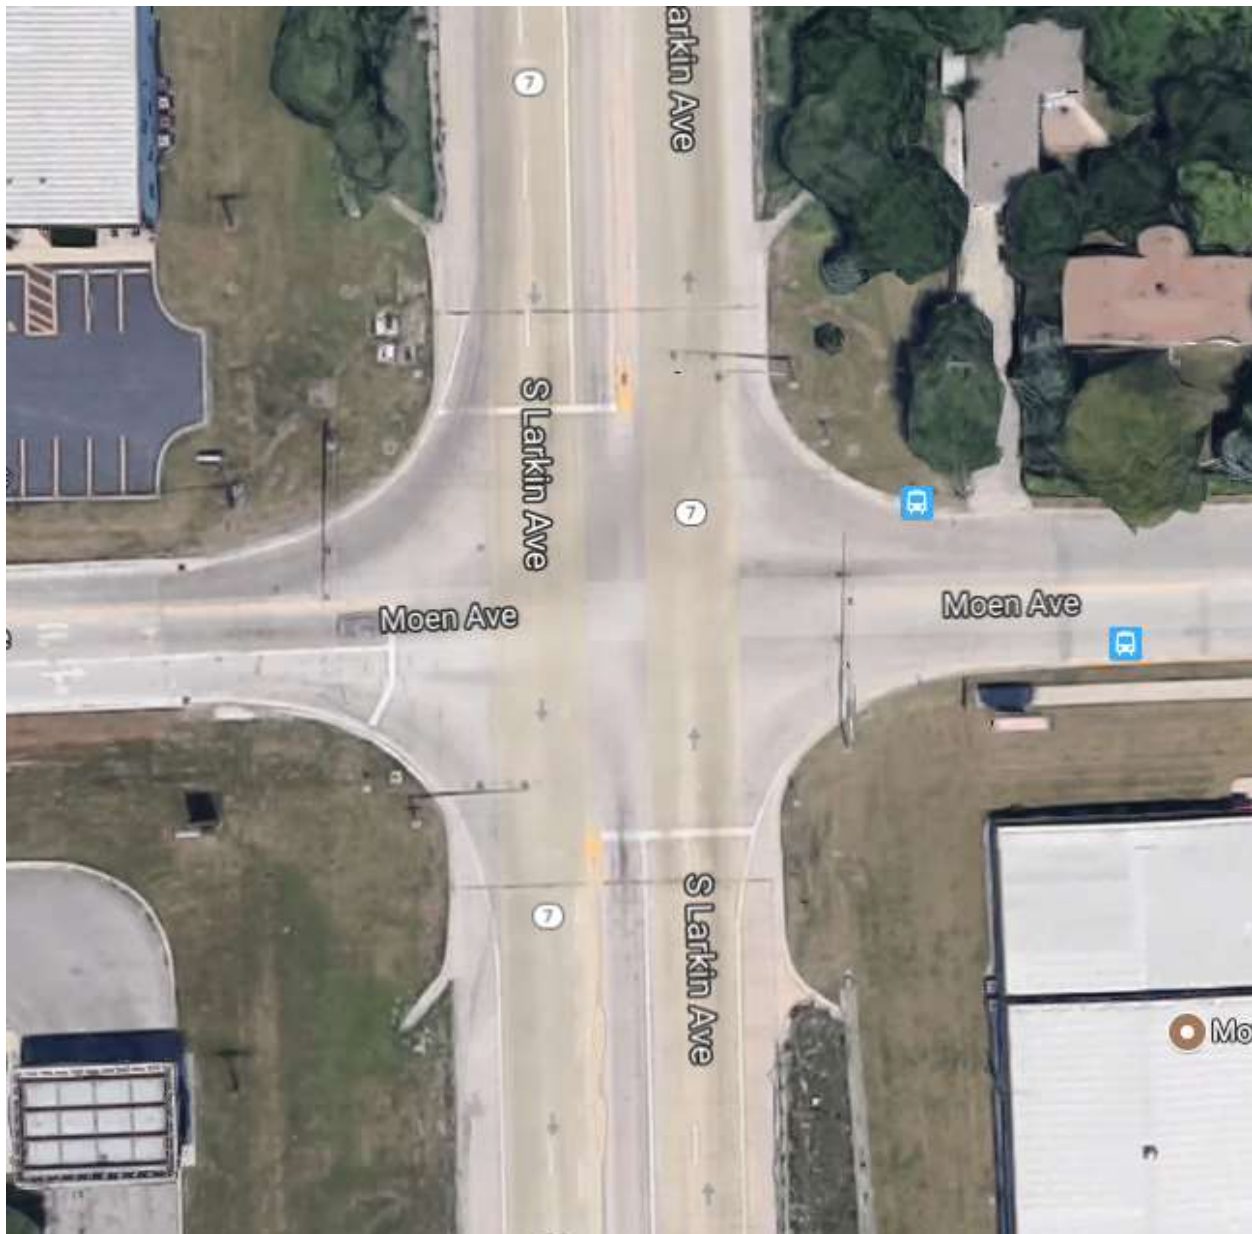
- RLR Photo Enforcement System monitors violations occurring on the southbound approach of the intersection
- RLR Photo Enforcement System installed: April 22, 2012

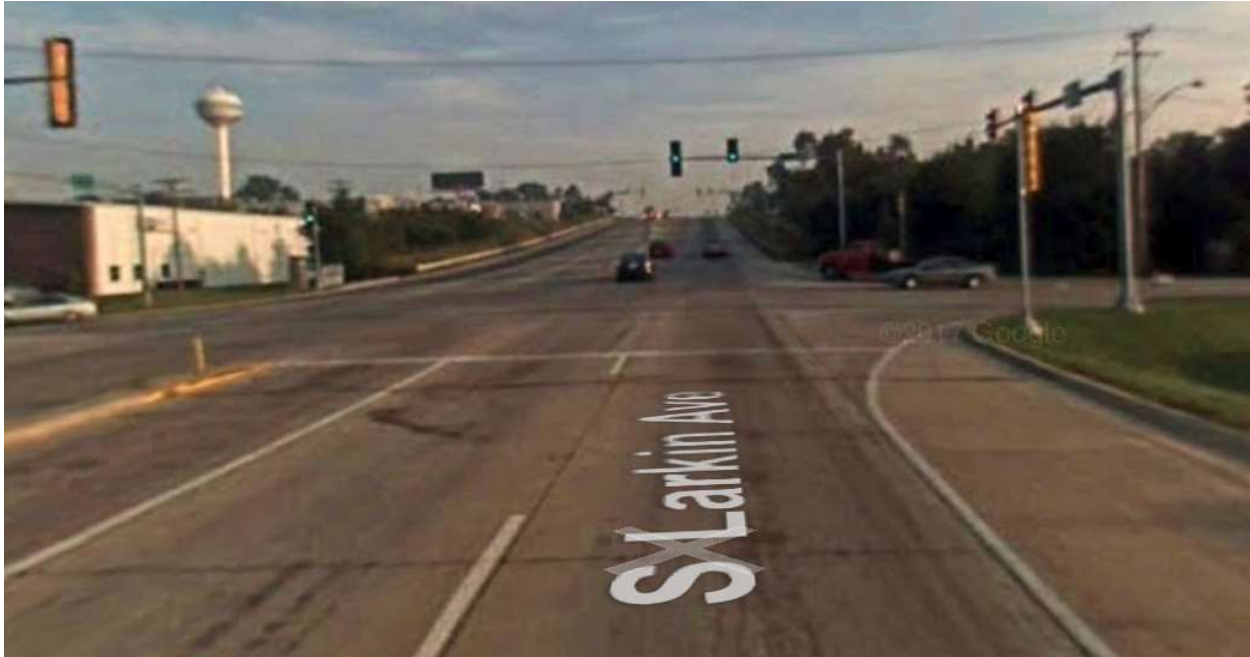
**IL Rte. 7 (Larkin) at Moen Avenue, Northbound Approach**

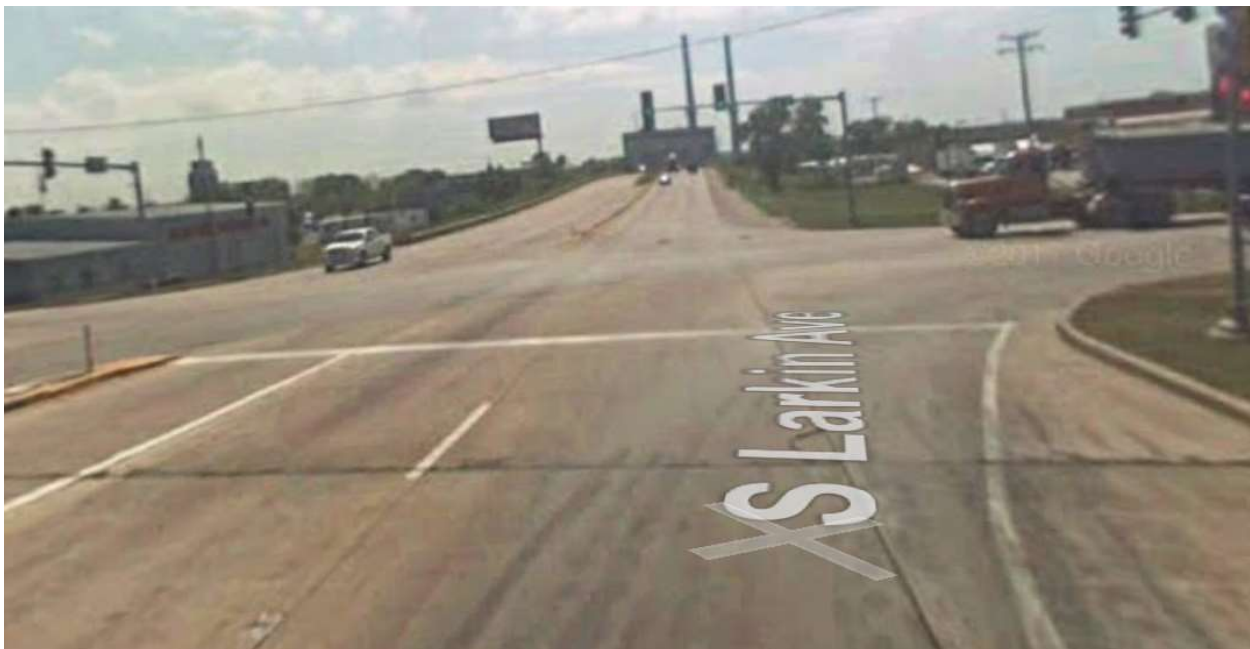
**IL Rte. 7 (Larkin) at Moen Avenue, Southbound Approach**

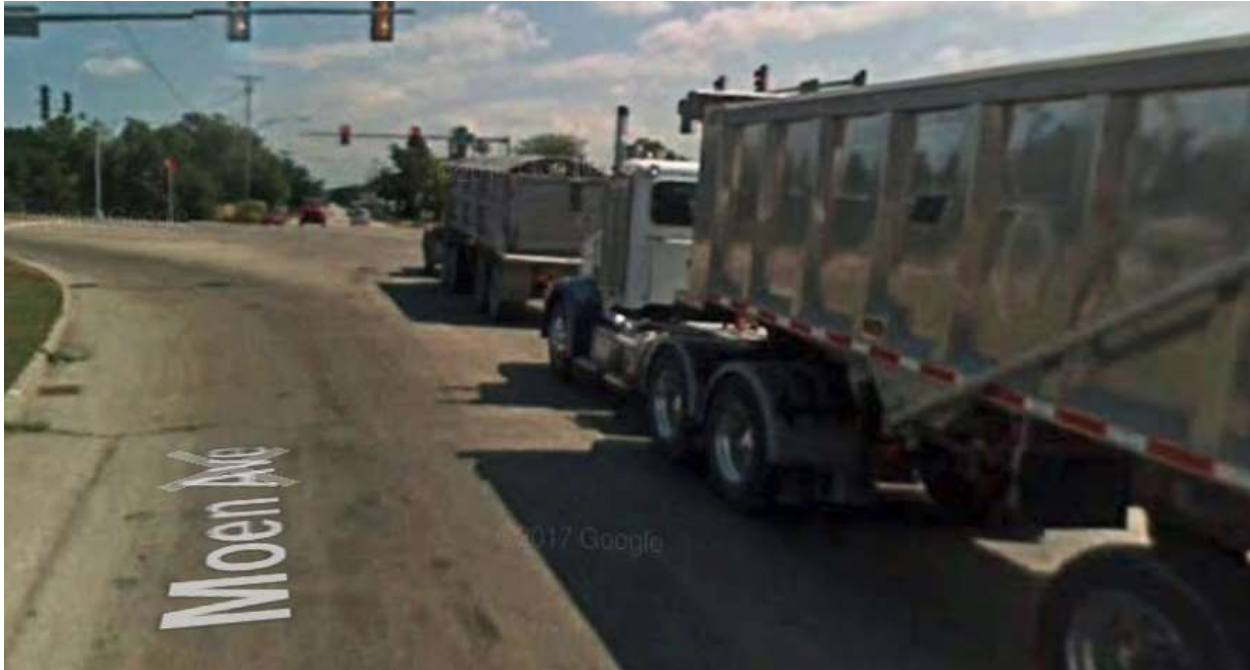
**IL Rte. 7 (Larkin) at Moen Avenue, Eastbound Approach**

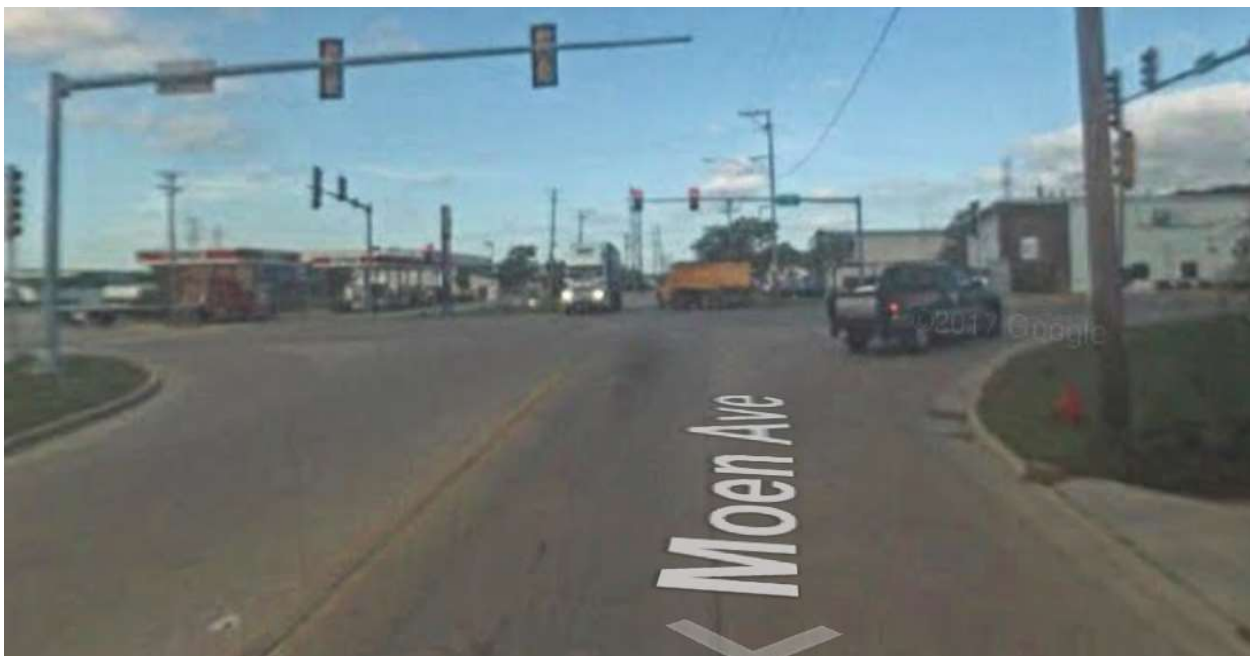
**IL Rte. 7 (Larkin) at Moen Avenue, Westbound Approach**

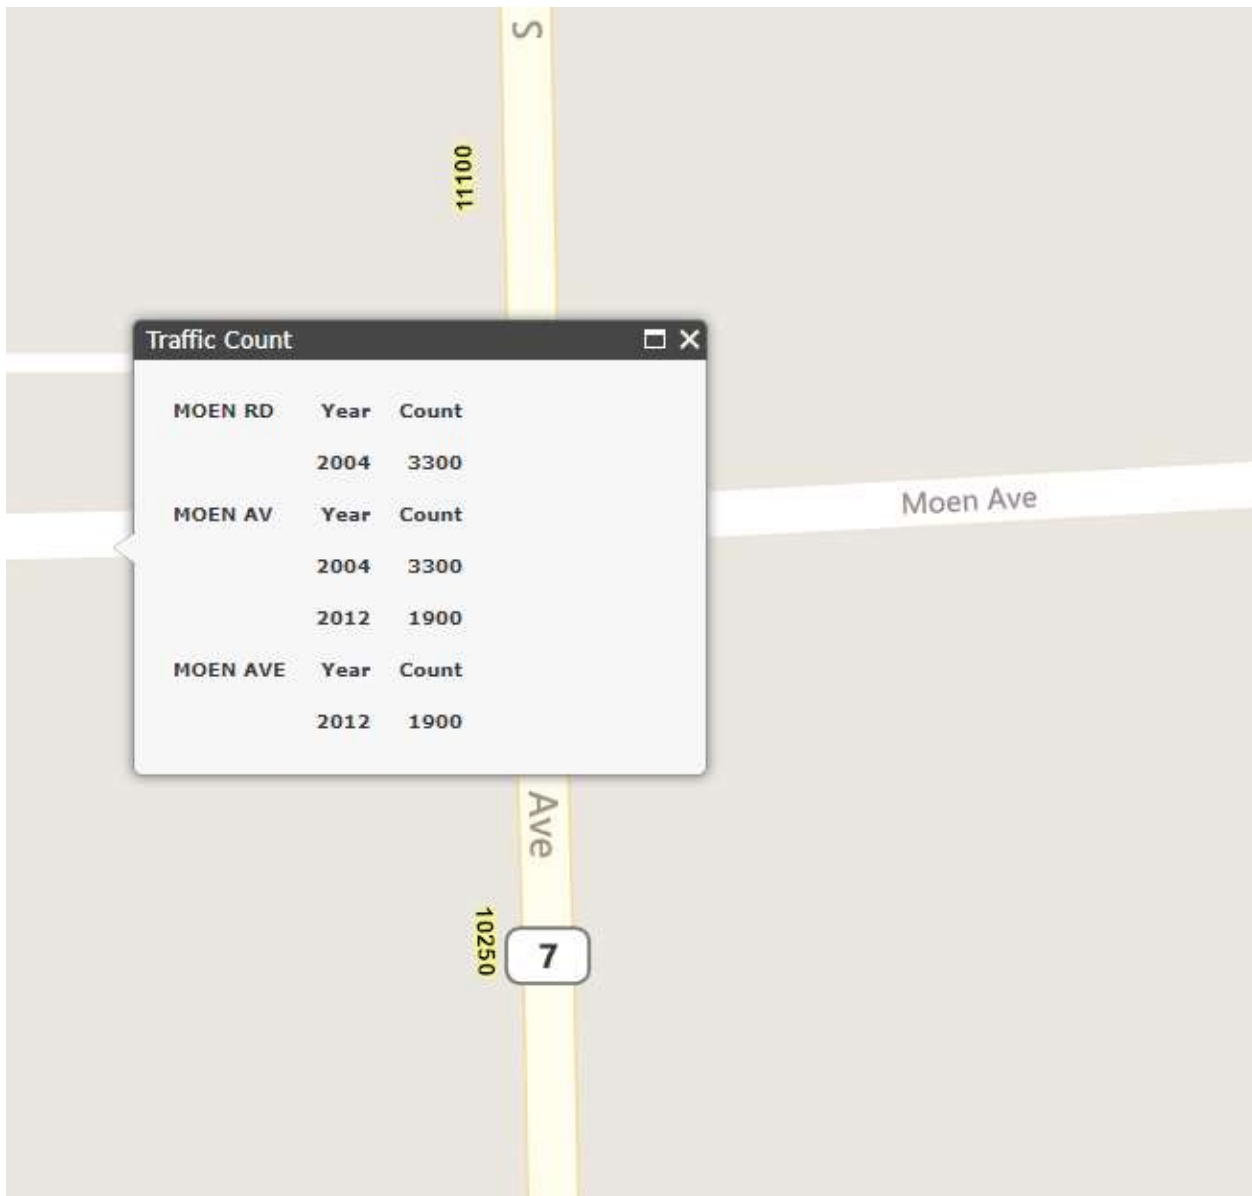
IL Rte. 7 (Larkin) at Moen Avenue (Eastbound)

- 3,300 (2004)
- 1,900 (2012)
